PORTLAND CONTAINER REPAIR CSM Site Summary

Oregon DEQ ECSI #: 2375

9449 N. Burgard Way

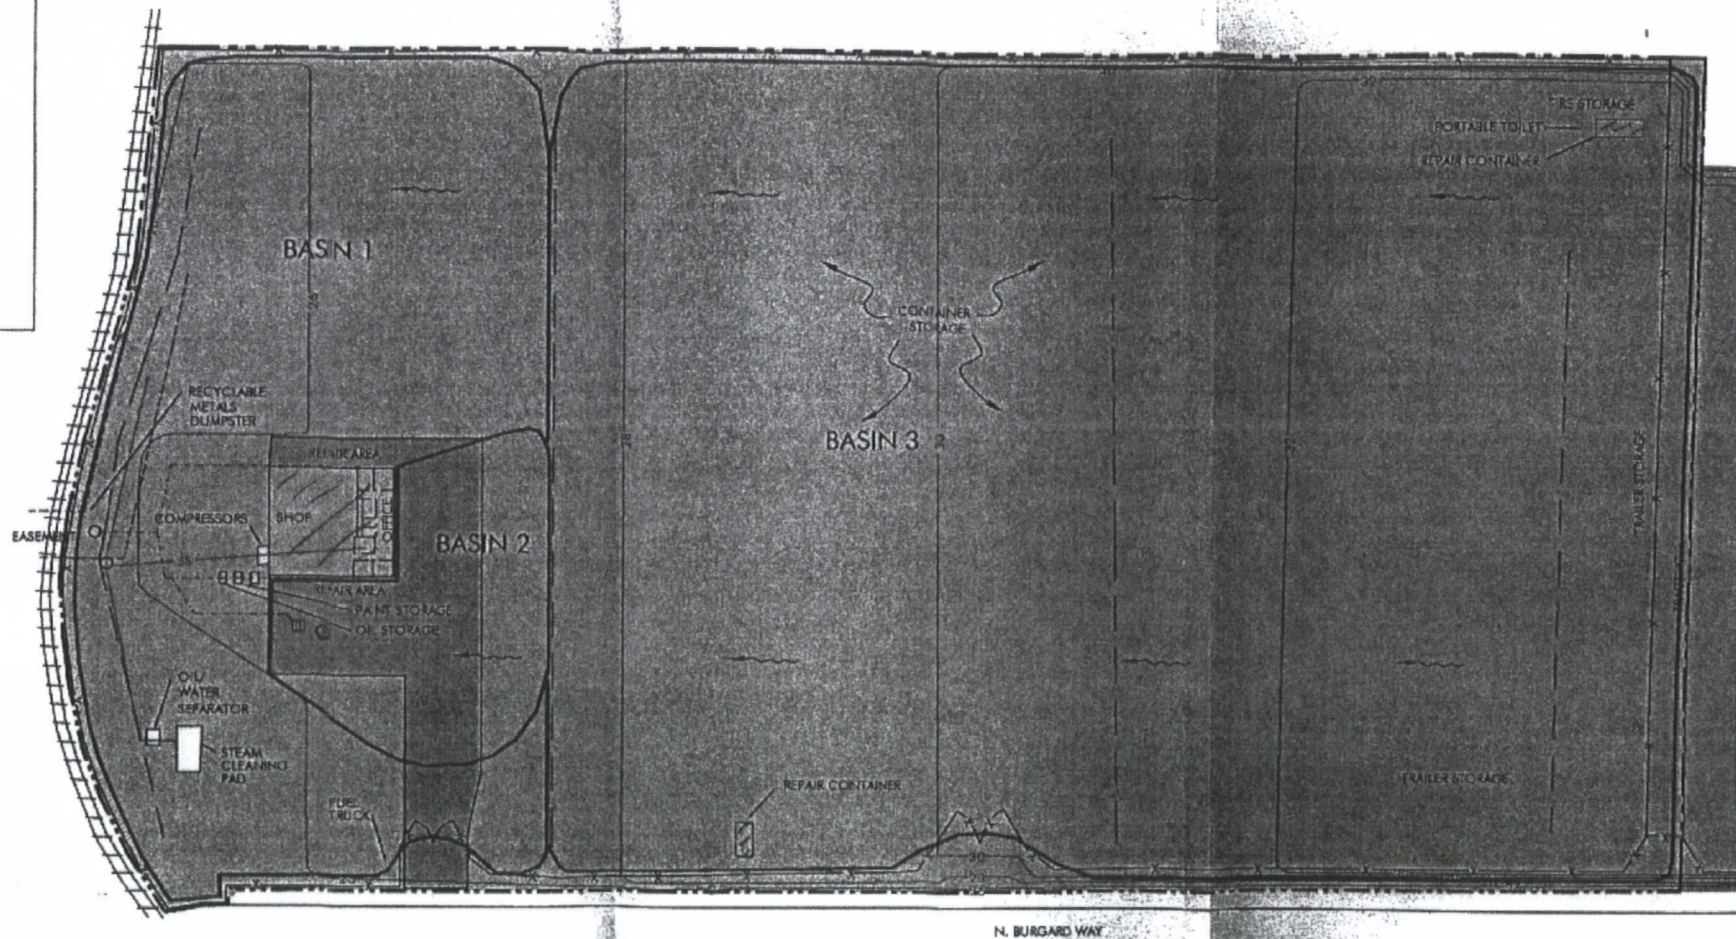
FIGURE
 2

Stormwater is conveyed through catch basins to a subsurface drainage system that eventually connects to the Schnitzer storm drainage system, which ultimately discharges to the slip [see Figure 2 from Century West (2001)] under an NPDES permit. Basin 1 contains one infiltration trench and one manhole for the storm drain system. The catch basin for Basin 2 drains the main outdoor work area, and it is equipped with a crude oil/water separator and sediment basin. Basin 3 includes three infiltration trenches and is entirely unpaved. Stormwater in this area infiltrates the surface soil (Century West 2001).
